A-E SERVICES TO PERFORM A CATHODIC PROTECTION SURVEY OF
THE BULK FUEL TERMINALS AT N.S.C., PEARL HARBOR, HAWAII

VOLUME II

JUNE 1982

PACIFIC CORROSION RESEARCH, INC.
5481 B COMMERCIAL DRIVE
HUNTINGTON BEACH, CALIFORNIA 92649

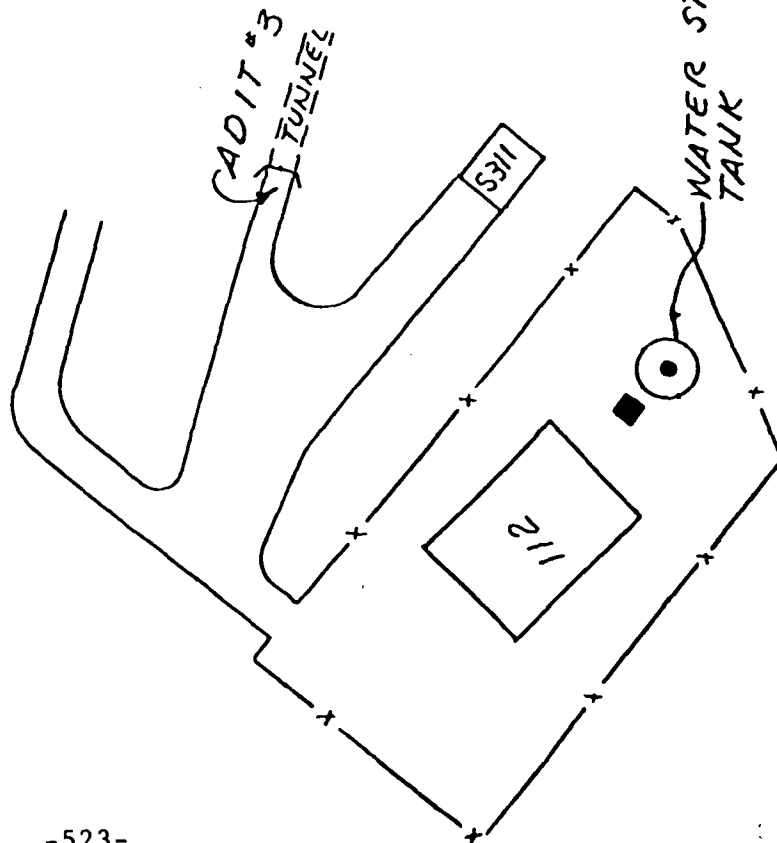
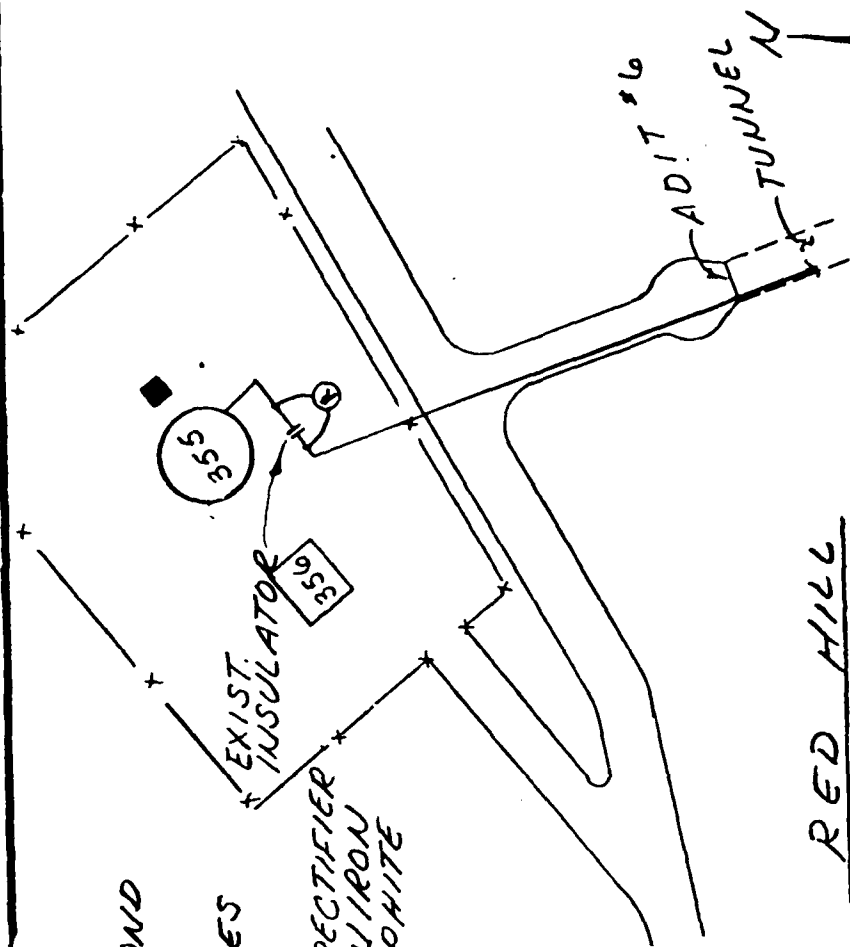
INSTALL MAGNESIUM ANODES INSIDE TANK

INSTALL A NEW OIL COOLED RECTIFIER AND INSTALL HIGH SILICON IRON TUBULAR ANODES OR GRAPHITE ANODES.
